Extending the Service Life of Oil Docks at **Port of Corpus Christi**

Utilization of Two-Stage Concrete Cathodic Protection System

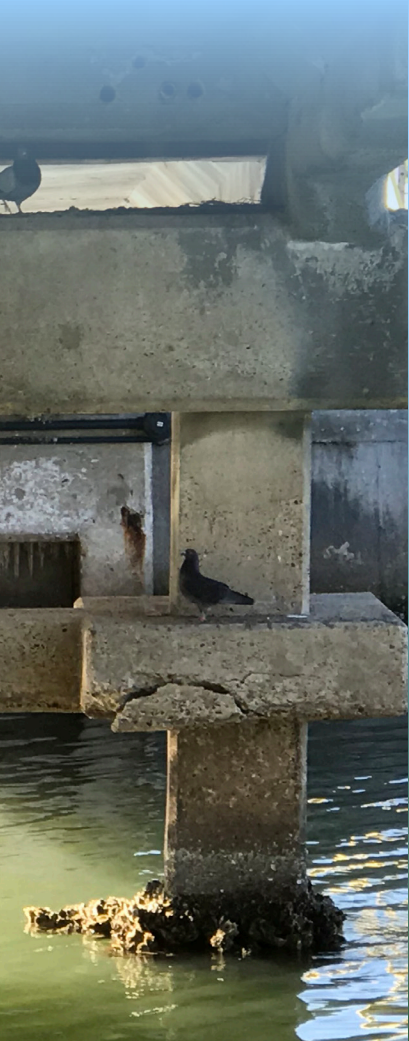
Figure 5: Visible Concrete Deterioration

As a result of this severe corrosion deterioration, in 1993 the Port's asset management division installed an arc spray zinc (ASZ) galvanic cathodic protection (GCP) system to mitigate corrosion activity and protect the two dock's reinforced concrete elements from further deterioration. In 2019, 26 years after the installation of the original GCP system, Oil Docks 4 and 7 again began to show signs of concrete deterioration due to reinforcement corrosion (Figure 5). This was due to the original ASZ system no longer providing protection to the oil docks. An ASZ system typically has a service life between 10-20 years depending on the exposure environment, with a coastal environment being the most aggressive on the CP service life.

As part of the new rehabilitation efforts for Oil Docks 4 and 7, the Port decided to extend the service life of the docks by installing a new ASZ cathodic protection system along with other dock upgrades such as a new pipe lift. The proposed installation of ASZ system required extended hours of continuous hot work during operational hours of the two oil docks. Since the two structures were mainly utilized for loading/offloading of crude oil, the Port had required that any hot work be kept to a minimum so that port operations would not be impacted during construction.

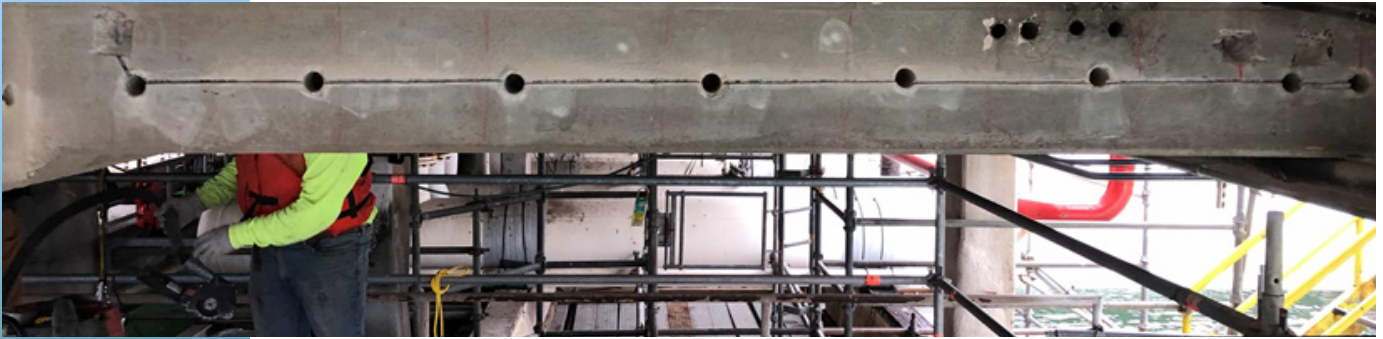
Figure 8: Drilling Anode Holes

1. Drilling a 2-inch diameter by 5-inch-deep hole at specified locations based on the Project Drawings (Figure 8).
2. Identify reinforcing steel at the anode zone and chip out a 3-inch by 3-inch area of concrete to expose rebar (Figure 9).
3. Create a rivet connection to the reinforcing bar and establish structure connection. Each structure connection wire was redirected to the test station via the common chase (Figure 9).

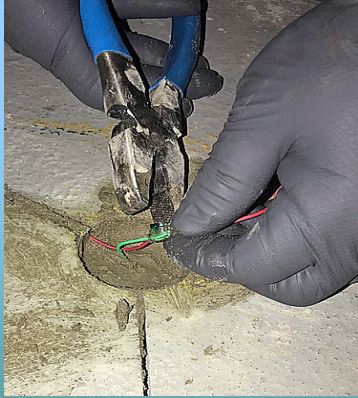
Figure 10: Step 4

4. Each anode was connected to the common header wire via a sealed button connection and each end of the common header wire was redirected to the test station via the common chase. A minimum of two reinforcing connections was established per string of 10 anodes (Figure 10).
5. Grout in two-stage anodes (Figure 11).
6. Install a silver-silver chloride reference electrode in the monitored beam/column and redirect wire to the test station via the common chase (Figure 12).
7. Grout all wires inside the common chase (Figure 13).

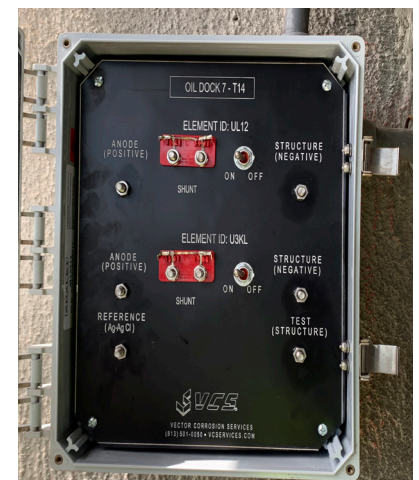
Figure 14: Installed Monitoring Station

Each dock was equipped with 14 test stations to monitor the performance of the CP system after completion of installation. Using the 14 test stations, a total of 36 zones (consisting of beams and columns) were monitored on each dock. A typical test station panel is shown in Figure 14. Each monitored zone was equipped with the following:

- Shunt: current output of anodes
- On-off Switch: interrupt the circuit to perform further testing.
- Reference electrode: polarization of each zone.

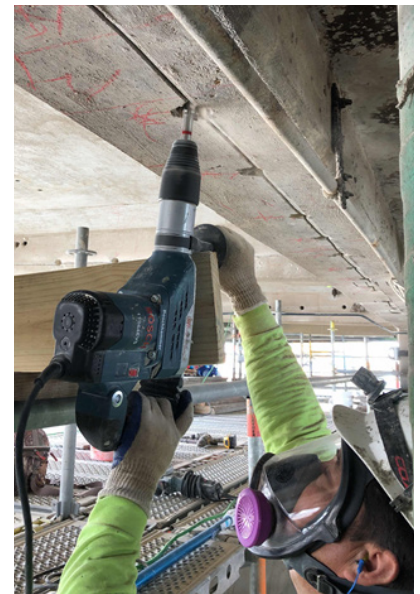
Figure 15: Drilling Overhead on Upper-Level Beams

- Several of the upper-level beams were obstructed on one side by large incoming pipelines carrying crude oil and reinforced with large C-Channels on the other side. This eliminated all options except for the anodes to be drilled from the bottom face of the beams which were heavily congested with reinforcing steel. Drilling anodes overhead into the upper-level beams congested with reinforcement slowed down the installation operations.
